Going back to its origins

Along with the atrium transformation that was designed to improve the circulation through the store, Marshall Field's completed an interior remodel of the first basement up to the 7th floor.

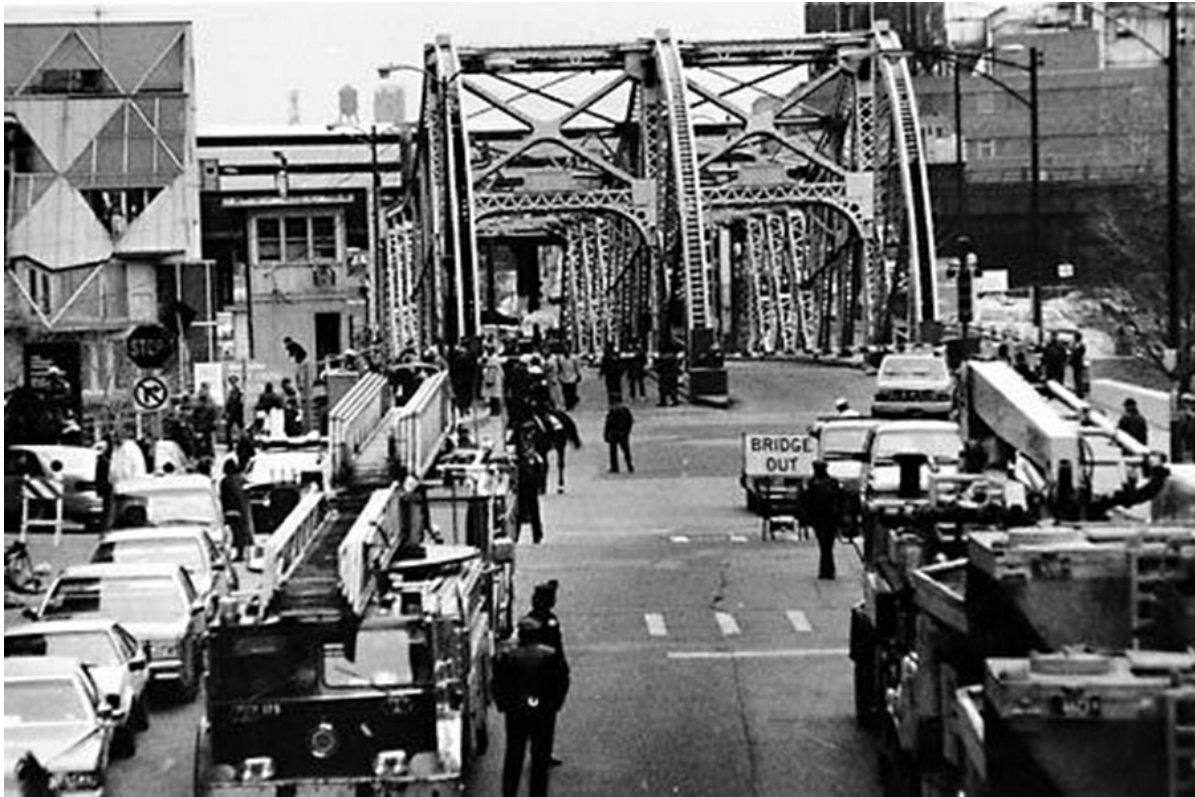
The scene looking west on the Kinzie Street Bridge where workers inadvertently punctured a century-old freight tunnel, causing massive basement flooding in dozens of buildings in Chicago's downtown area. -- *Tribune photo by Charles Cherney, April 13, 1992.*

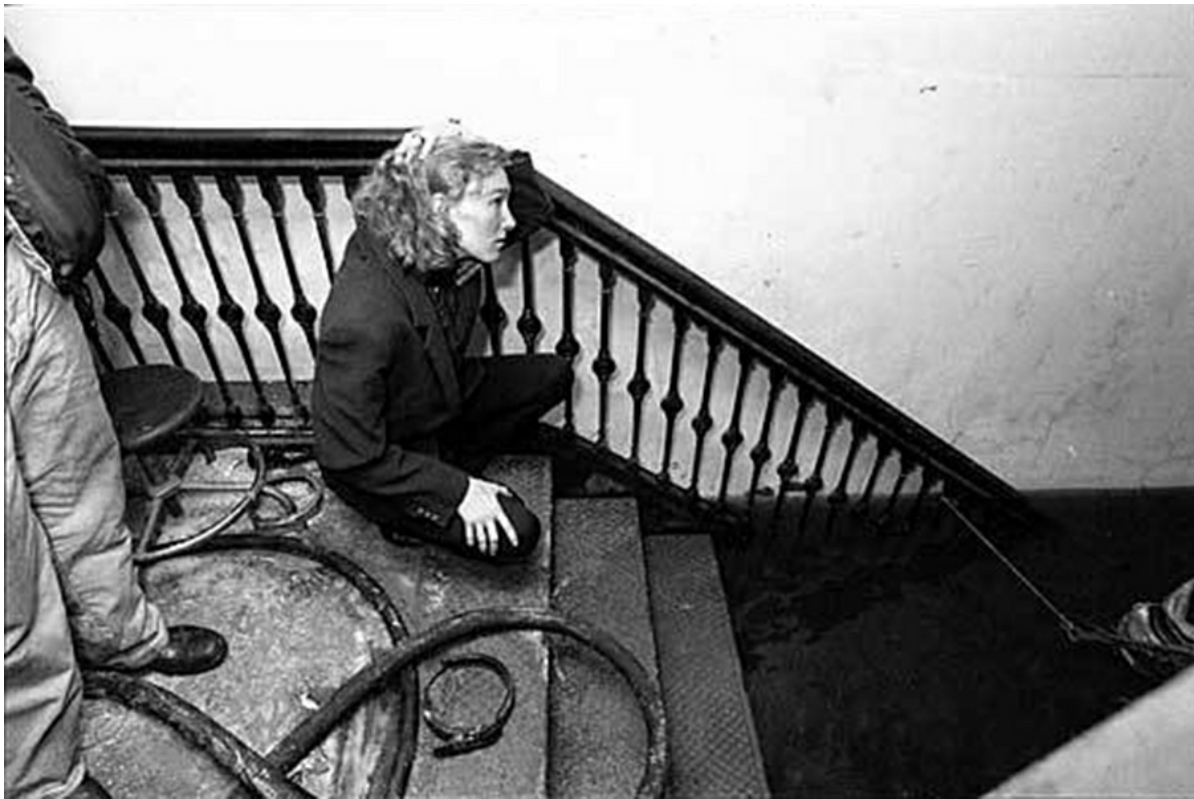
The flood had done its damage. Water completely filled the bottom two basements. Operations came to a halt. The electrical system was blown. Product was destroyed. The cafeteria, offices, the boilers and the support for every mechanical – all were under water for two to three weeks. And all were destroyed.

The electrical system was ravaged. Looking down the stairs to the 2nd and 3rd basements below, the water glowed from the electricity surging through it from the electrical vaults in the 3rd basement. We worked with ComEd to shut off the electricity, so we could go down and begin the massive cleanup and restoration process.

Marshall Field's employee Cathy Hoffman looks down into the water of the flooded third basement at the downtown State Street store. -- Tribune photo by Chris Walker, April 16, 1992.

To release the elevators that were stuck below water level, we sent scuba divers down. The Pepper team pumped the water out, brought in temporary electrical service and cleared the bottom two basements of contaminated debris and sediment from the rivers. The men wore hazmat suits and protective masks to stay safe.
