A CLEARLY-DEFINED SCHEDULE

EXAMINING THE STRUCTURE

PAINSTAKING PROCESS TO BRING BACK THE COLOR

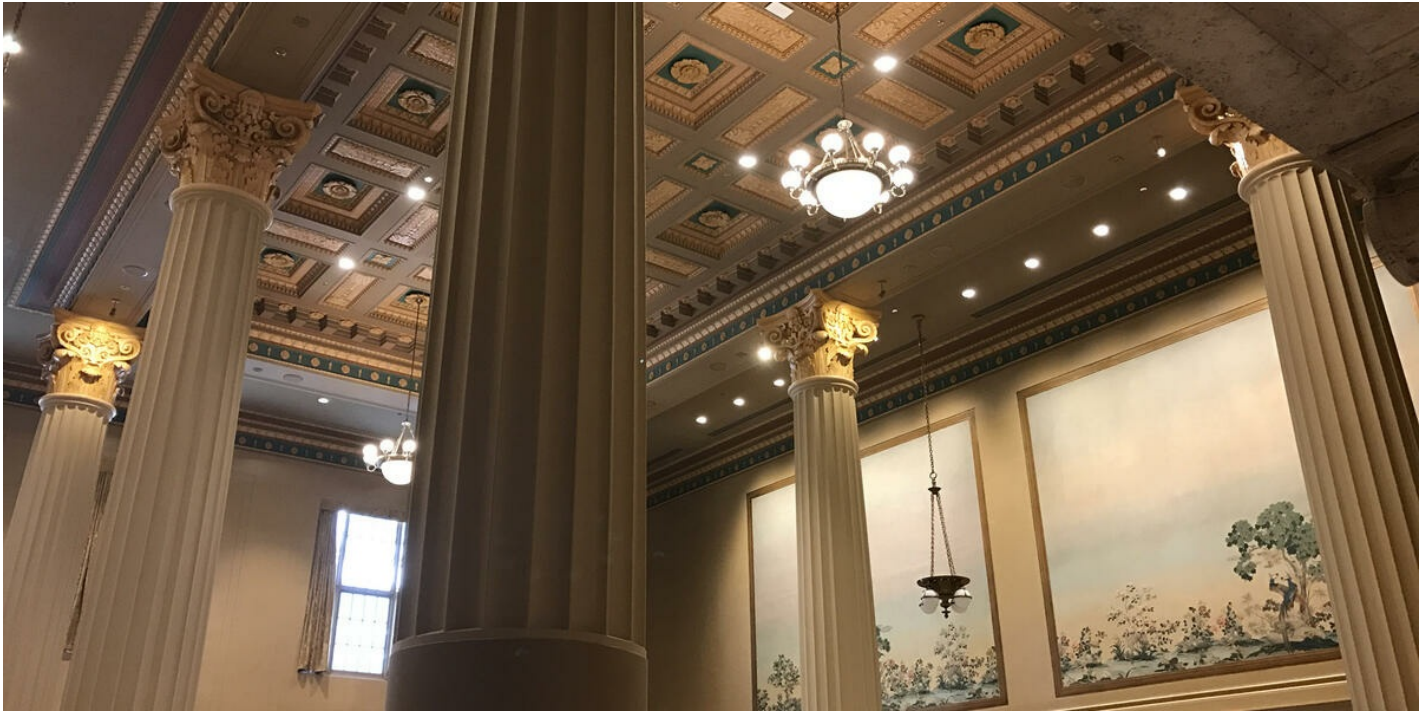
Amtrak wanted the room to function properly for today's needs, while also maintaining its historic integrity. They saw the opportunity to go beyond renovating the space to restoring it to its original intent and retained Goettsch Partners to advise them on the design. As such, the project required careful review and negotiation to ensure the correct elements were incorporated into the space.

But it was more than a facelift. All the infrastructure had to be set up, which meant going down two floors to pick up air and exhausting it three floors up.

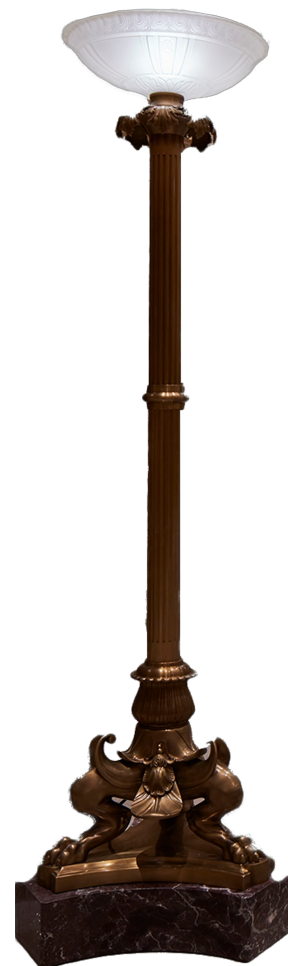
Though the lamp posts in the room are considered a furnishing, since they are not an original feature, they still required approval by the historical society.

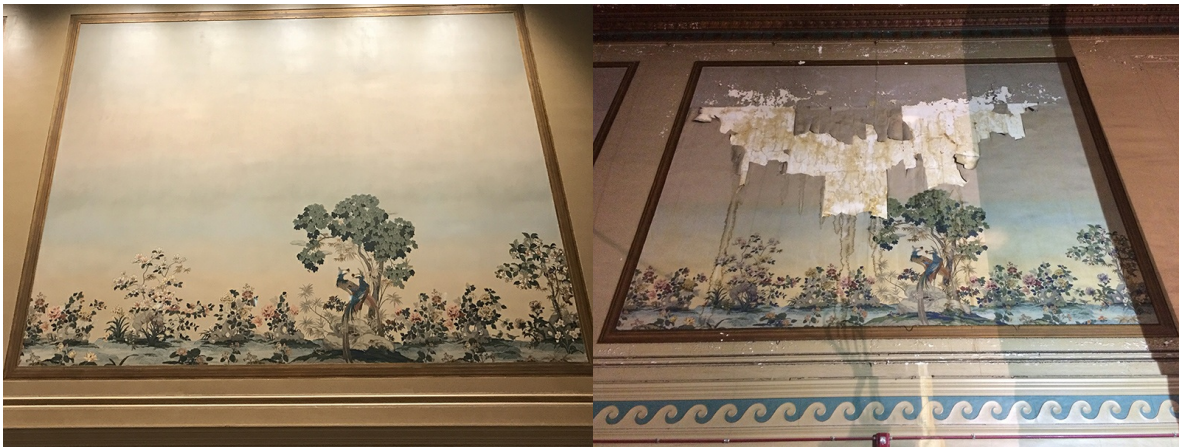
Another significant historical feature was a set of four ink murals that hung as wallpaper on the upper part of the walls. Each mural was composed of seven different types of wallpaper strips, and depending how they were configured, they would make a different image.

For three of the murals, many of the original strips were disintegrated. To restore them, the existing strips were scanned and converted into designs that were replicated on new canvas. The new strips were then hand-painted and incorporated into the original work. The fourth had to be completely replicated.

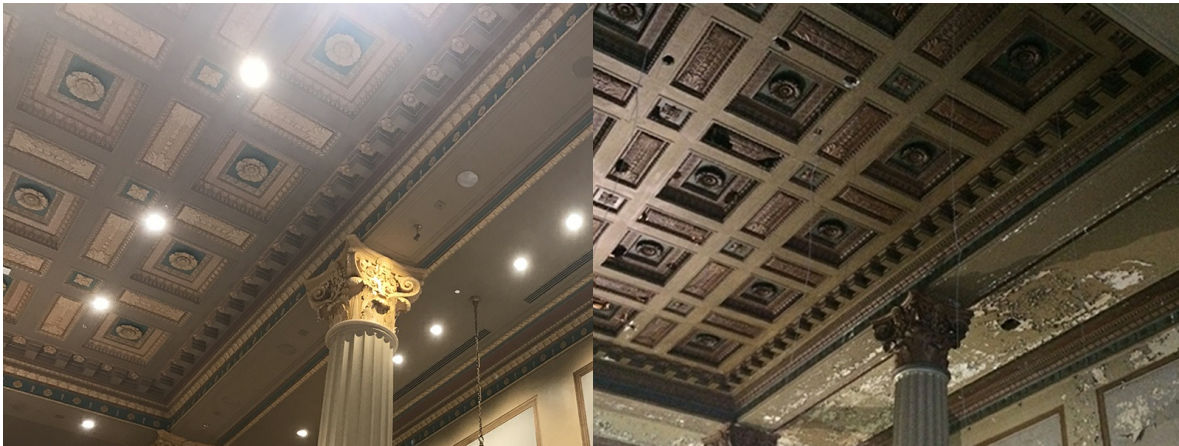
Up to 15 percent of the ceiling plaster was lost, including special features like rosettes. As EverGreene was examining the paint, we got to work on the ceiling. We removed existing plaster pieces to cast new molds, and then the shape was submitted for approval before repairs were made.

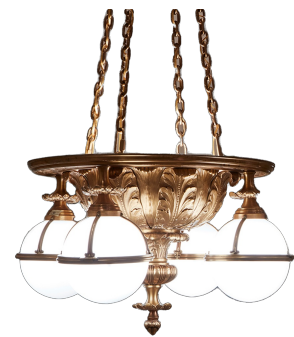
Nine bronze chandeliers hang on 15-foot bronze chains. The original fixtures were discovered stashed away in the basement.

In all, nine bronze chandeliers hang on 15-foot bronze chains. Despite holding onto them, none of them was complete - missing finials, decorative caps and other bronze pieces. Seven were restored and two had to be completely replicated. A local Chicago restorer was able to clean and polish them down to the original finish. Like the paint, the exact age and brass finish had to be determined so they could replicate and cast new bronze to match. Finally, the chandeliers were retrofitted with new LED lamps. It took 18 weeks to restore and replicate the ceiling fixtures, so initiating the process and releasing them quickly was vital to the schedule.
